HOCKANUM RIVER BASIN  
MANCHESTER, CONNECTICUT

PORTER RESERVOIR DAM  
CT 00014

PHASE I INSPECTION REPORT  
NATIONAL DAM INSPECTION PROGRAM

MAY 1980

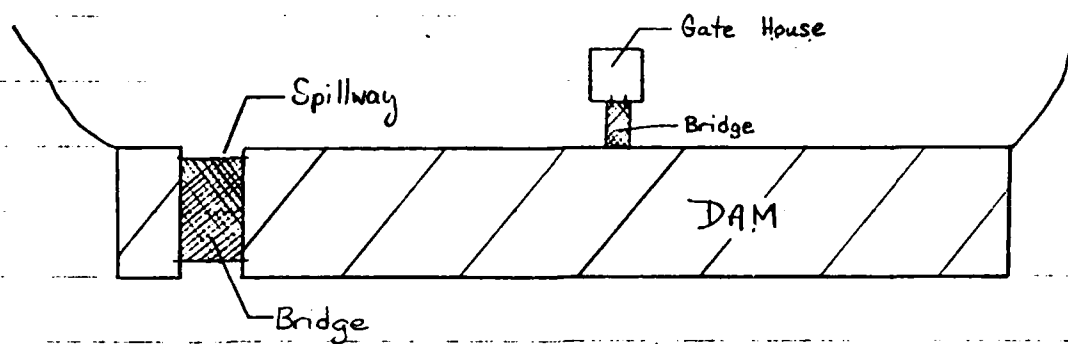
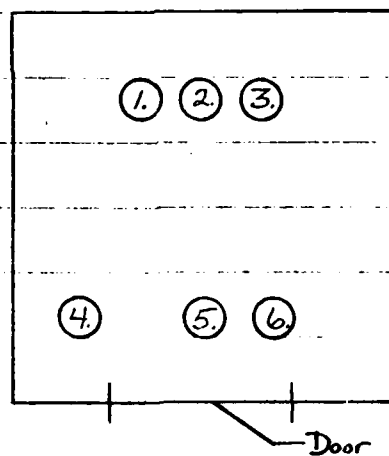
Porter Reservoir and Gate House: Capacity = 27 Million Gallons

1. 16" Influent pipe, Elevation = 409.5 feet NGVD
2. 16" Influent pipe, Elevation = 403.0 feet NGVD
3. 16" Influent pipe, Elevation = 398.0 feet NGVD
4. 8" Bypass pipe, Elevation = 398.5 feet NGVD
5. 6" Blow-off pipe.
6. 12" Effluent pipe.
